September 1, 1987

80386-B1
STEPPING INFORMATION

REVISION: SEPTEMBER 1, 1987

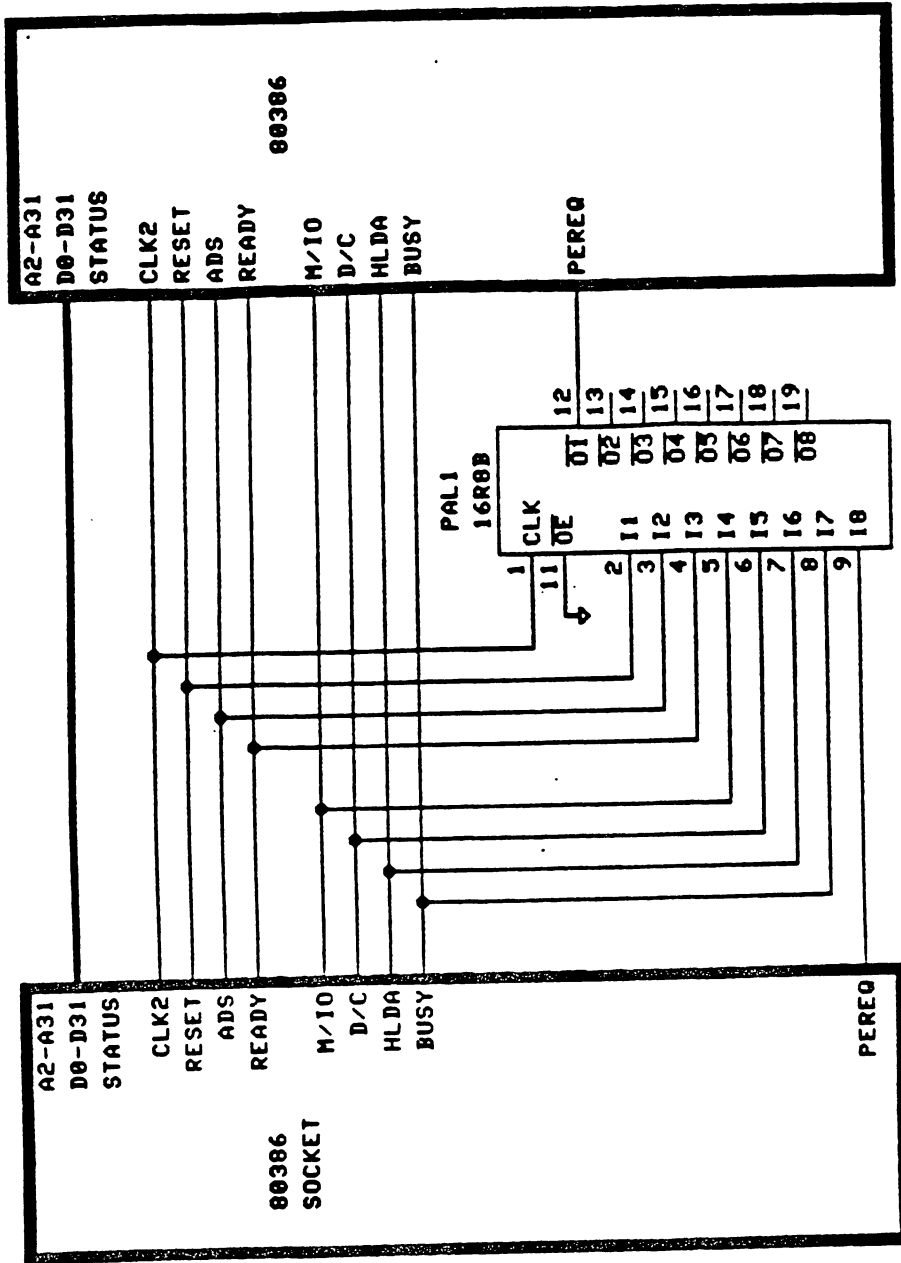
PEREQ CONTROL
ED GROCHOWSKI 8-27-87

Problem: Under certain conditions of memory wait-states and HOLD requests, a problem can occur. If paging is enabled, and the prefetch unit (internal to the 80386) requests a memory read cycle at the same time that the coprocessor requests an operand transfer cycle (by asserting PEREQ), then the processor may drive out an incorrect address when transferring data from the coprocessor. Specifically, the processor will drive an I/O address of 000000FCH (with A31 low), rather than 800000FCH (with A31 high). As a result, the 80387 may be left in an indeterminate state. This errata occurs only when the 80386 is executing an ESC instruction with a memory operand while paging is enabled.

The workaround consists of adding a PAL to control the PEREQ (Processor Extension REQuest) signal received by the 80386. The basic idea is to prevent a PEREQ from hitting the processor at a time when a prefetch request may be pending internally. Specifically, the PAL contains a state machine to monitor 80386 bus activity, a counter to keep track of idle cycles, and a state machine to mask PEREQ if necessary.

The operation of the circuit is as follows. During active bus cycles, the counter is cleared. When an idle cycle occurs (with HLDA negated) the counter is incremented. When 8 idle cycles have been counted, the circuit assumes the prefetch queue is full and allows a PEREQ to pass through to the 80386. Otherwise, 80386 PEREQ is forced inactive. Thus, a coprocessor request can only be honored *after* the prefetcher has stopped. By monitoring the processor's bus cycles, the circuit functions properly for all combinations of HOLD requests and memory wait-states. In applying this circuit, one should allow at least 8 clocks between consecutive HOLD requests, in order to let ESC instructions complete. Also note that this method of determining when the prefetch queue is full works only during ESC instructions with memory operands, since the processor must wait for the ESC to finish before executing any subsequent instructions.
